Natur & Miljø 2013 Nyborg, Danmark, 29. og 30. Maj 2013

SPOR B - VANDPLANINDSATSEN

Udenlandske erfaringer – eksempler på vandløbsarbejdet i Tyskland River Restoration in the North German Lowland – Year 13 of the WFD¹

Tent, Ludwig, Dr. Edmund Siemers-Stiftung Buchenweg 11, D – 21255 Tostedt, Germany E-Mail: ludwig.tent@gmx.net <u>www.salmonidenfreund.de</u>

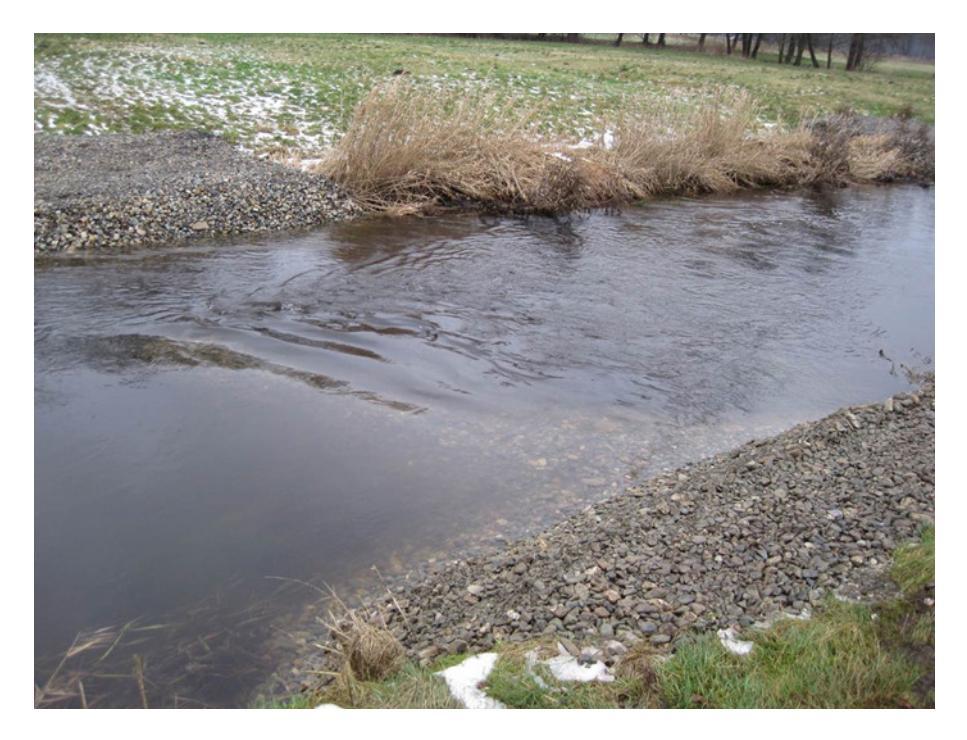
Figure 1: In-stream structure – "microgroin" (Lenkbuhne) inducing current and morphological variation by gravel and boulders.

Examples are given for rural and urban waters where especially the salmonid reaches have been restored by in-stream restoration, using gravel (fig. 1), boulders and wood (fig. 2). Trout, brook and river lamprey, stone loach and accompanying characteristic invertebrates reveal the positive results. Adopt-a-brook groups and engaged individuals co-operate with water authorities, land owners and maintenance organisations to further improve the situation.

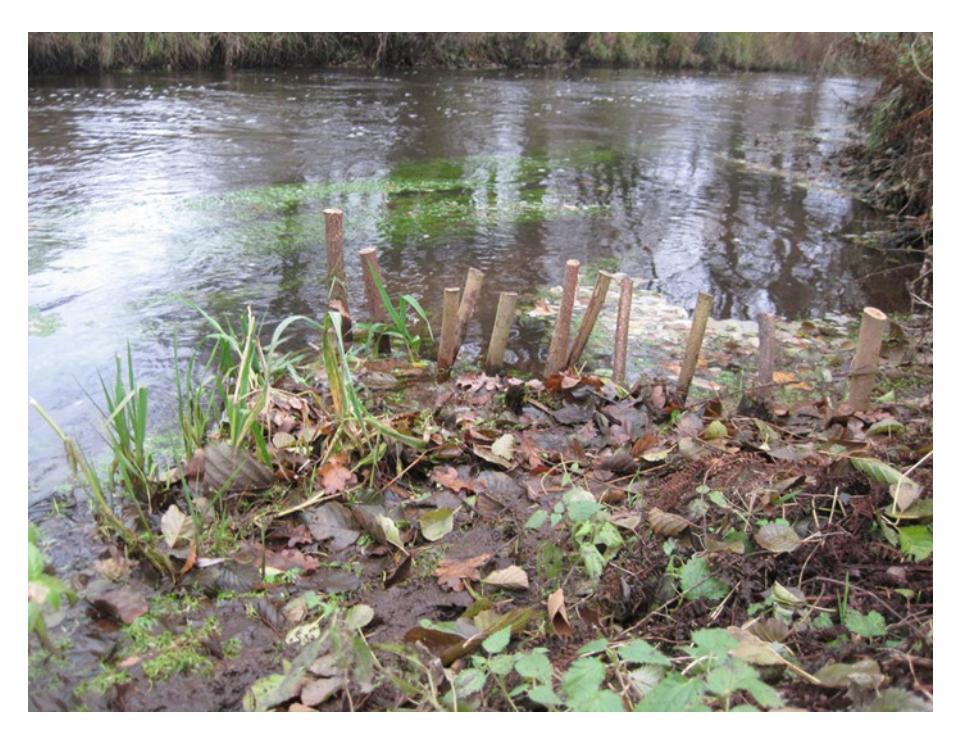
Figure 2: Sticks and stakes – inexpensive tool to structure riverbed and shore, preventing erosion, where trees are lacking.
